Masters Home Inspections LLC
10 Golden Eagle Ct.
Westminster, Maryland 21158

5719 Meyer Ave
New Market, Maryland

Others Present Buyer's Agent Property Occupied Vacant
Estimated Age 13 Years - 2002 Entrance Faces
Inspection Date 02/13/2015
Start Time 2:30 End Time 5:30
Electric On Yes No Not Applicable
Gas/Oil On Yes No Not Applicable
Water On Yes No Not Applicable
Temperature +/- 20 Degrees
Weather Partly sunny Soil Conditions Frozen
Space Below Grade Basement
Building Type Single family Garage Attached
Sewage Disposal City How Verified Visual Inspection

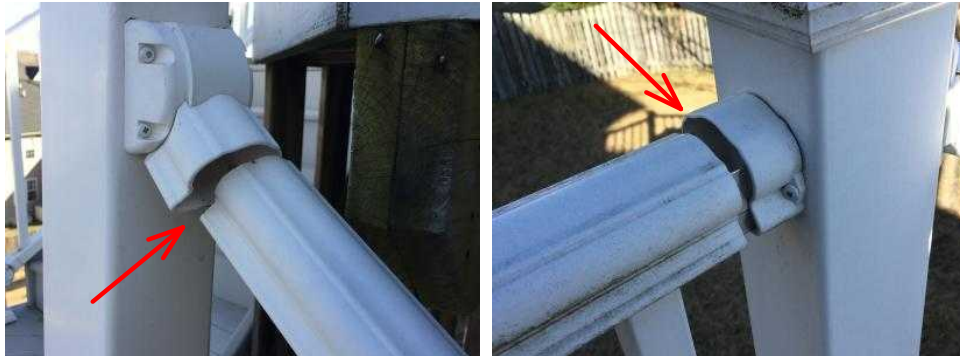
1. Driveway: Asphalt
2. Walks: Concrete
3. Steps/Stoops: Brick
4. Porch: Brick
5. Patio:
6. Deck: Stained wood, Treated wood There are a few areas of deck railing that have become detached and/or loose. Consider repair.

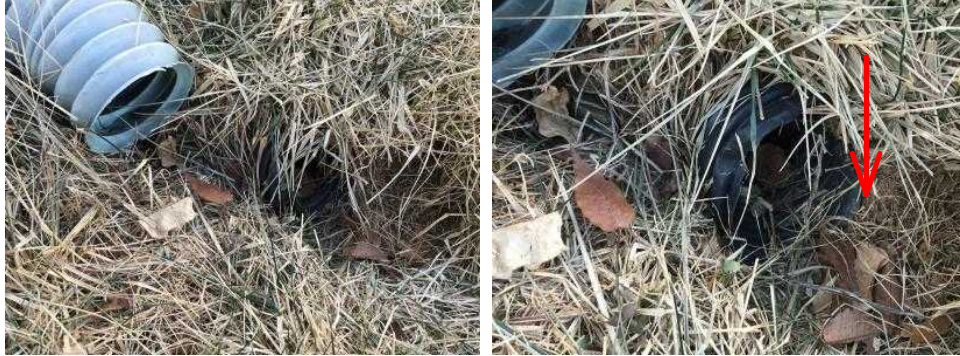
7. Balcony:
8. Grading: Moderate slope
9. Swale:
10. Vegetation: Shrubs, Trees
11. Window Wells:
12. Retaining Walls:
13. Basement Stairwell:
14. Basement Stairwell Drain:
15. Exterior Surface Drain: Open drain pipe Buried drainage pipe from the front guttering system appears to terminate in the back / left corner of the house. The area has some erosion and likely holds water near the foundation. Consider extending drainage to move water away from the house.

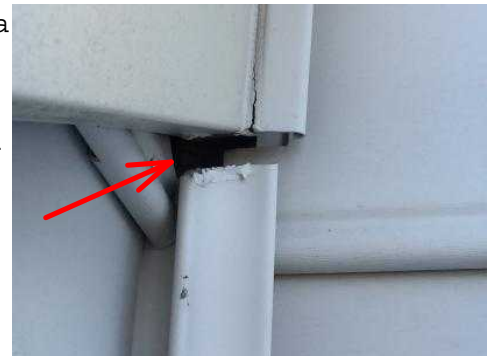
1. Type: Brick veneer, Vinyl siding
 2. Trim: Aluminum, Vinyl, Wood There is an area on the rear of the house where the right side roof meets the main portion of the house. The trim and siding appears to be cut short leaving a sizable gap. Consider sealing this area to prevent water / insect from entering into the house.

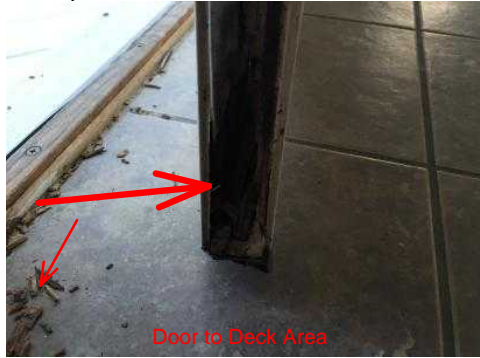
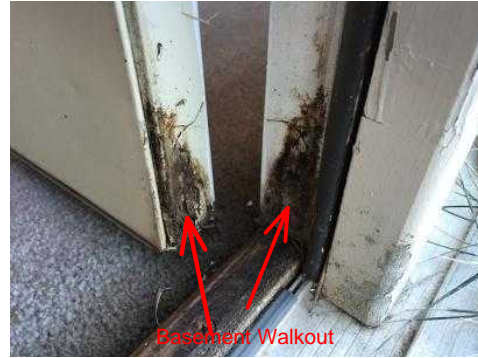
3. Fascia: Aluminum
 4. Soffits: Vinyl
 5. Door Bell: Hard wired
 6. Entry Doors: Metal Note: Entry door does not latch appropriately. This is likely defective hardware and not a door issue. Consider repair or changing out door locks.
 7. Patio Door: French door Wood rot and deterioration noted on both the 1st level door to the deck area and the basement walkout. This is likely due to water damage. Consider repair.

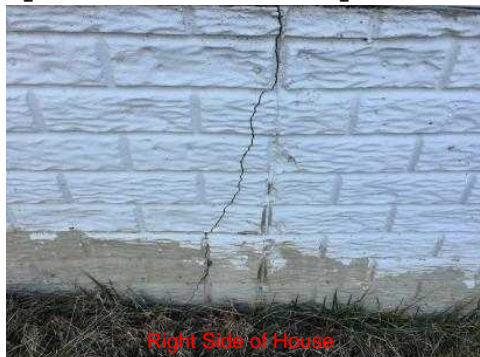
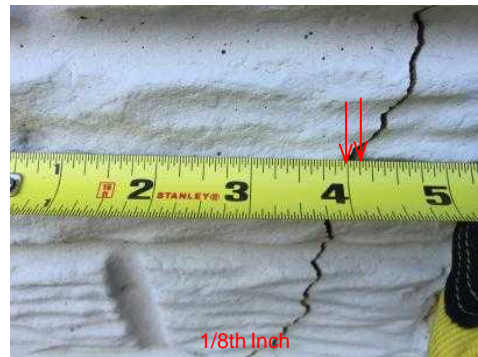
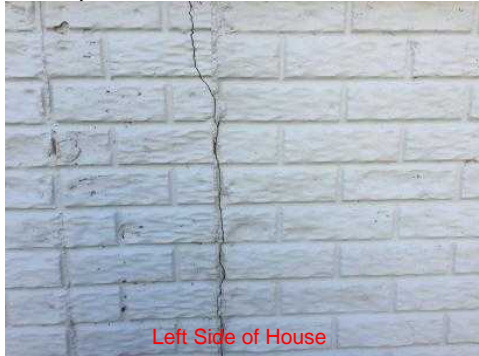
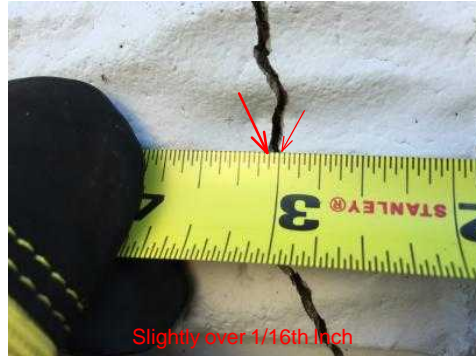
- 1. Structure Type: Wood frame
- 2. Foundation: Poured Foundation cracks noted on each side of the house. This can be common in poured foundations and can be caused by expansion and contraction during the curing process or some minor settlement. General rule of thumb is to be treating these areas when the width of the crack reaches 1/8th inch. Consider applying a epoxy foundation sealer to these areas and continue to watch over time for expansion. If they continue to expand, consider following up with a licensed professional for further evaluation.

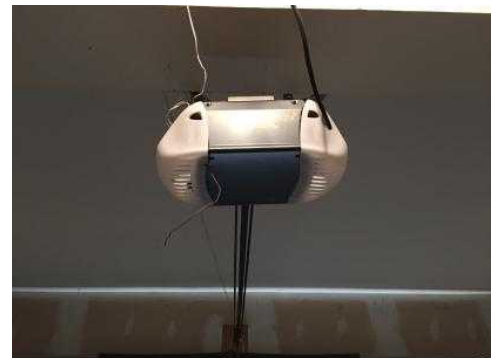
- 1. Type of Structure: Tuck under Car Spaces: 2
- 2. Garage Doors: Fiberglass
- 3. Door Operation: Mechanized Door opener does not work at this time. Consider repair.

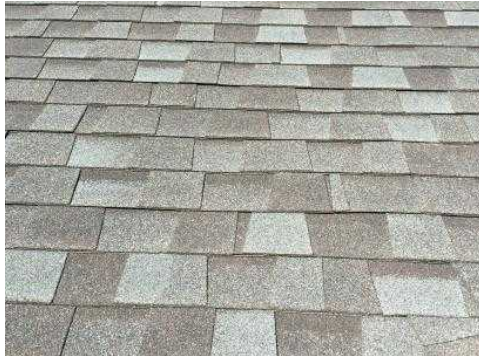
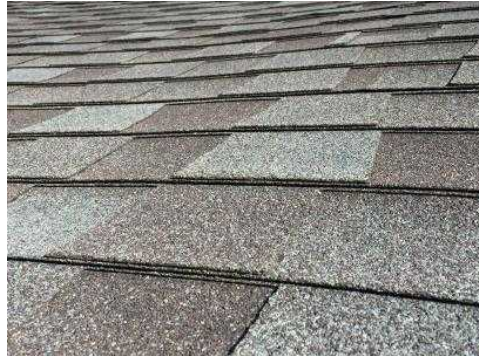
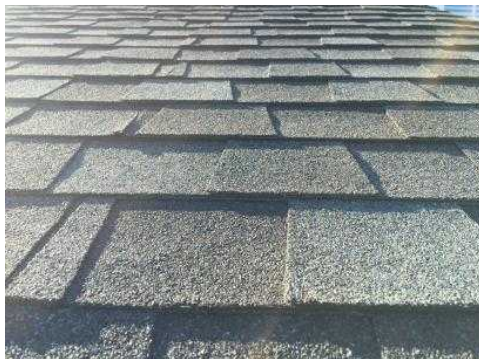
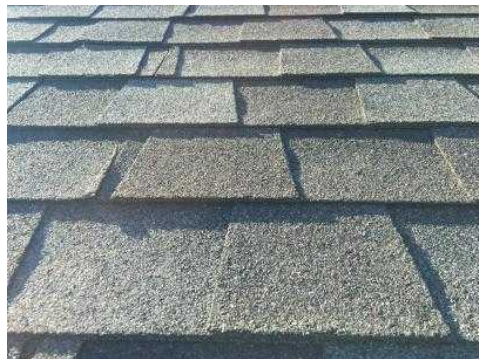
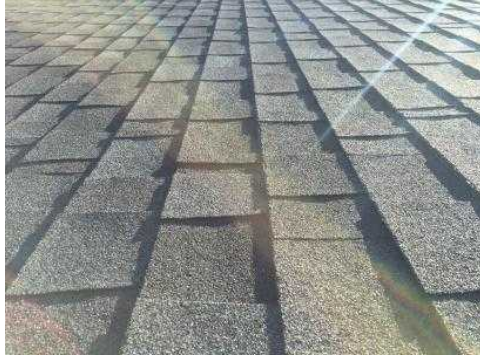
Shingles are lying flat and are well sealed at this time. No cupping or curling noted. No penetrations noted. Good granular surface noted.

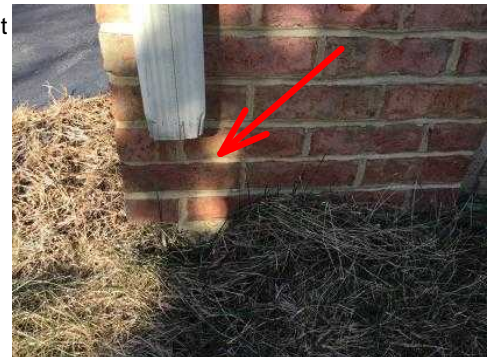
- 4. Type: Gable
- 5. Approximate Age: 13 Years - 2002
- 6. Flashing: Aluminum
- 7. Valleys: Asphalt shingle
- 8. Skylights:
- 9. Plumbing Vents: PVC & Galvanized
- 10. Electrical Mast:
- 11. Gutters: Aluminum
- 12. Downspouts: Aluminum
- 13. Leader/Extension: Missing Extension missing on downspout at the front right corner of the house. Consider repair.

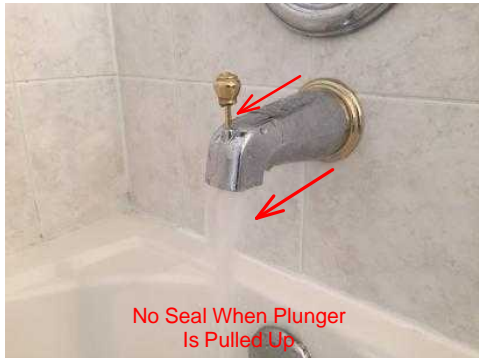
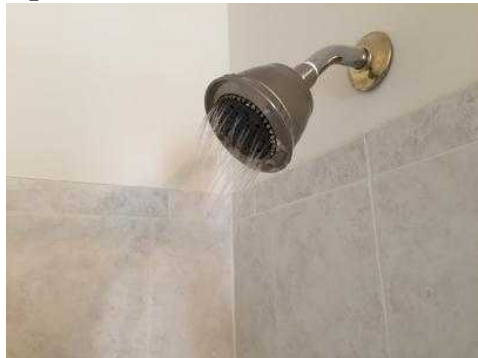
Bad seal noted on the tub faucet. Does not provide seal to utilize the shower head. Consider repair.

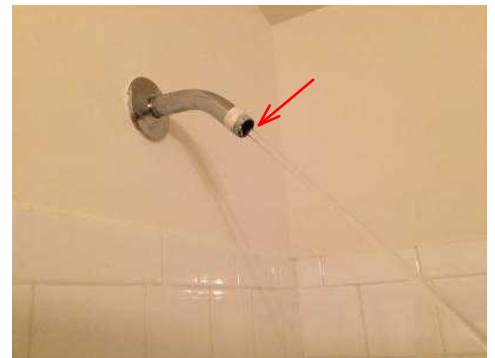
12. Shower/Surround: Fiberglass pan and fiberglass surround Basement bathroom has no shower head. Consider repair

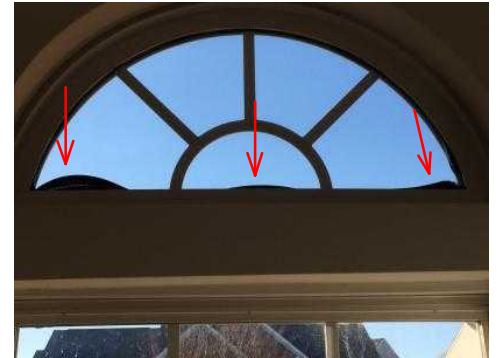
1. Closet: Single
2. Ceiling: Paint
3. Walls: Paint
4. Floor: Carpet, Hardwood
5. Doors: Hollow wood
6. Windows: Vinyl double hung, Non-opening
Decorative windows in the front of the house have seals that are bringing to displace.

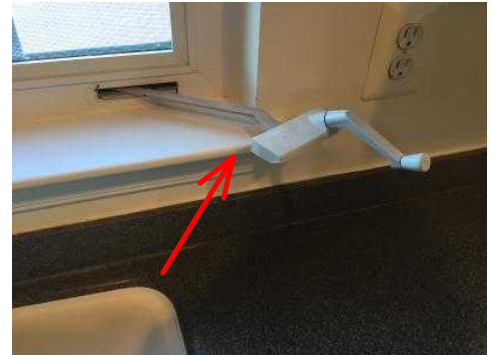
19. Windows: Vinyl casement Defective hardware noted on kitchen window above the sink. Consider repair.

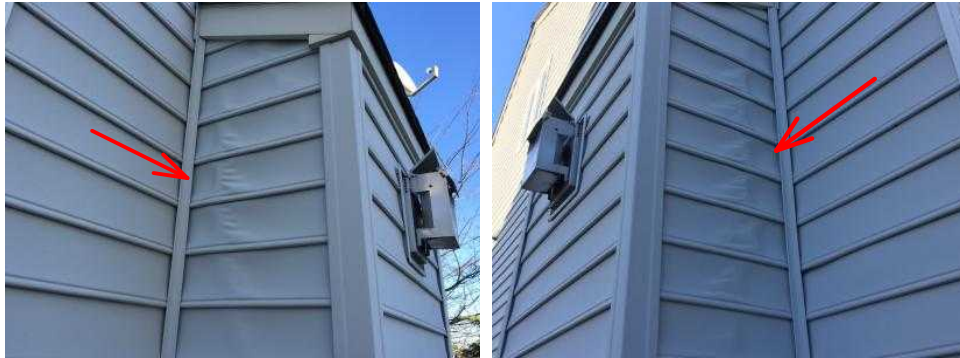
- 1. Freestanding Stove:
- 2. Fireplace Construction: Prefab Melting noted on the exterior siding around the fireplace insert and venting system. Consider having a further evaluation done on the venting system to ensure it is correct. It is apparent that heat is escaping and causing damage to the siding.

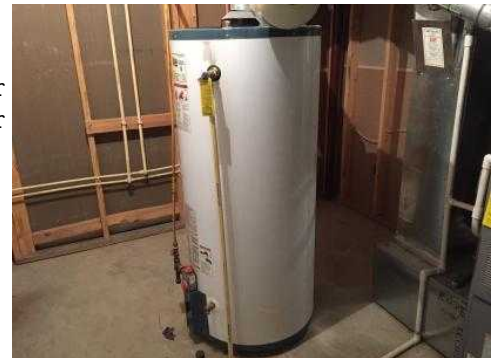
- 8. Water Heater Operation: Note: Gas was shut off to water heater at the time of this inspection. Could not verify if hot water is adequate however no signs of leakage or rusting is found.

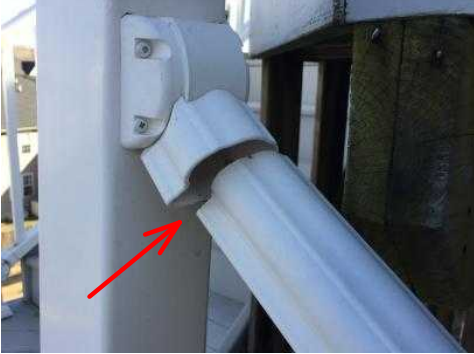
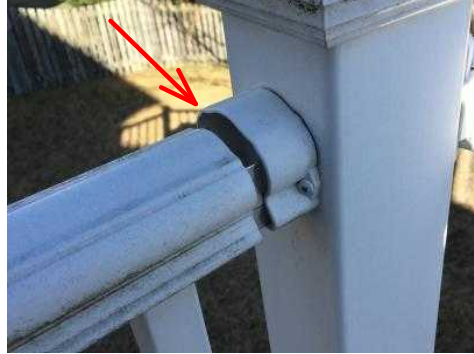
1. Deck: Stained wood, Treated wood There are a few areas of deck railing that have become detached and/or loose. Consider repair.

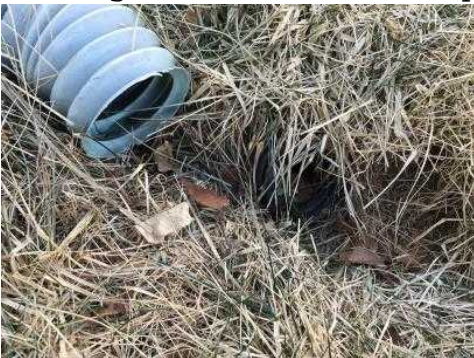
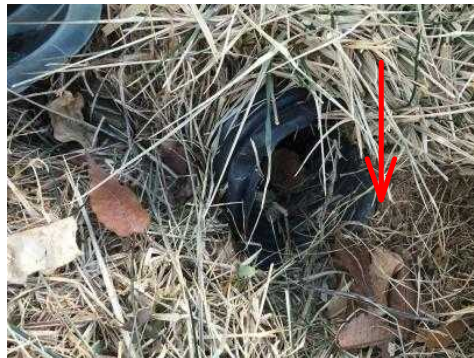
2. Exterior Surface Drain: Open drain pipe Buried drainage pipe from the front guttering system appears to terminate in the back / left corner of the house. The area has some erosion and likely holds water near the foundation. Consider extending drainage to move water away from the house.

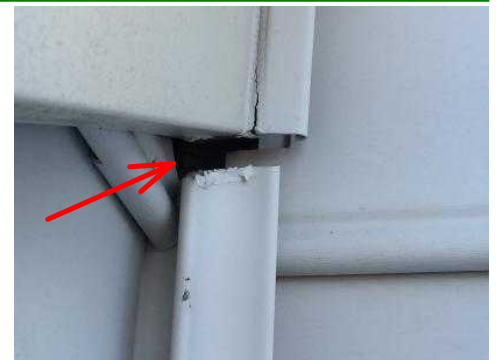
3. Trim: Aluminum, Vinyl, Wood There is an area on the rear of the house where the right side roof meets the main portion of the house. The trim and siding appears to be cut short leaving a sizable gap. Consider sealing this area to prevent water / insect from entering into the house.

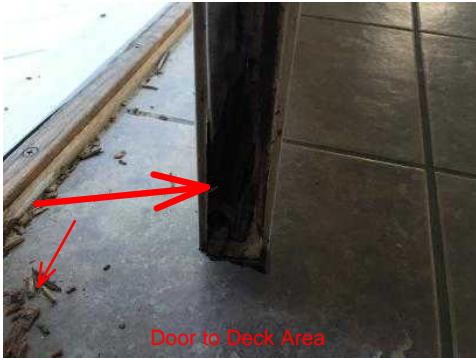
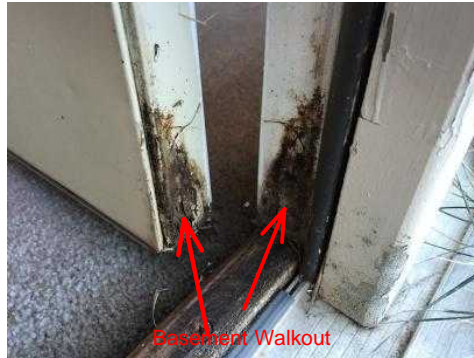
5. Patio Door: French door Wood rot and deterioration noted on both the 1st level door to the deck area and the basement walkout. This is likely due to water damage. Consider repair.

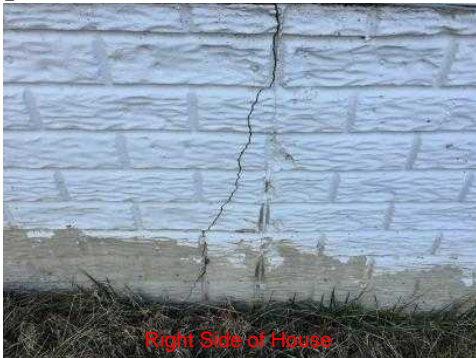
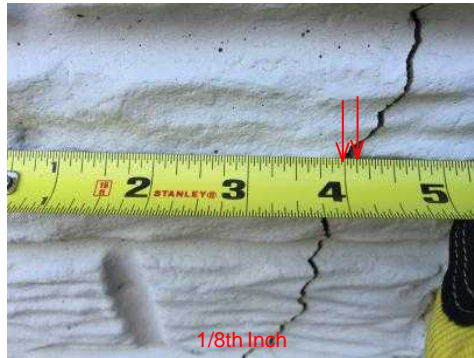
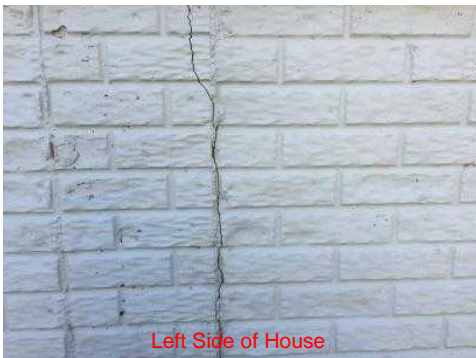
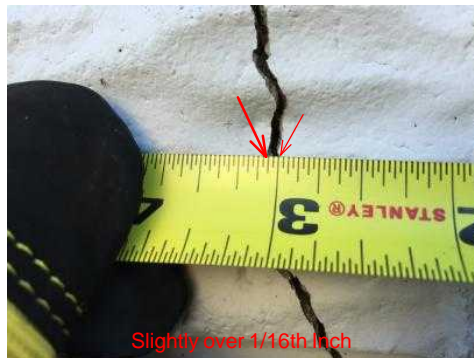
6. Foundation: Poured Foundation cracks noted on each side of the house. This can be common in poured foundations and can be caused by expansion and contraction during the curing process or some minor settlement. General rule of thumb is to begin treating these areas when the width of the crack reaches 1/8th inch. Consider applying a epoxy foundation sealer to these areas and continue to watch over time for expansion. If they continue to expand, consider following up with a licensed professional for further evaluation.

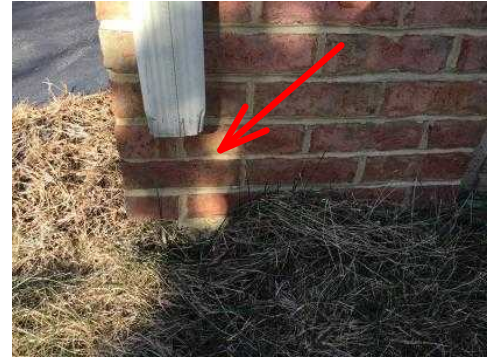
7. Leader/Extension: Missing Extension missing on downspout at the front right corner of the house. Consider repair.

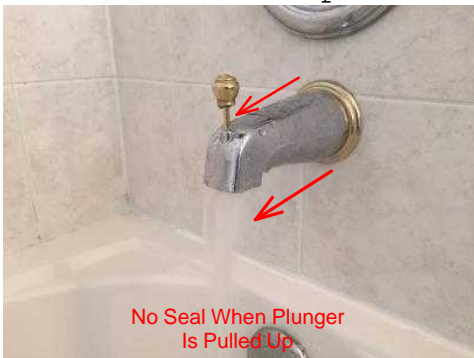
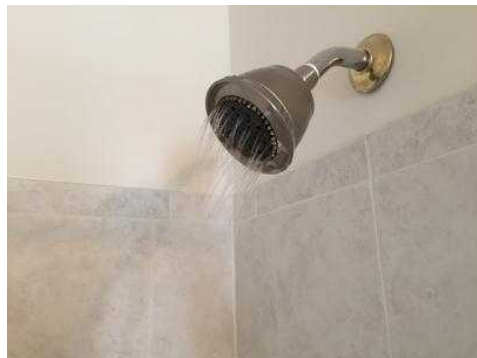
Bad seal noted on the tub faucet. Does not provide seal to utilize the shower head. Consider repair.

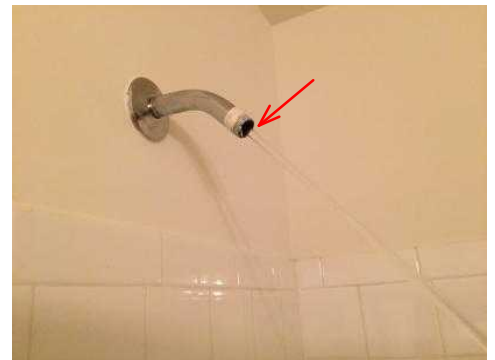
9. 1st floor main, 2nd floor main, Master, Basement Bathroom Shower/Surround: Fiberglass pan and fiberglass surround Basement bathroom has no shower head. Consider repair

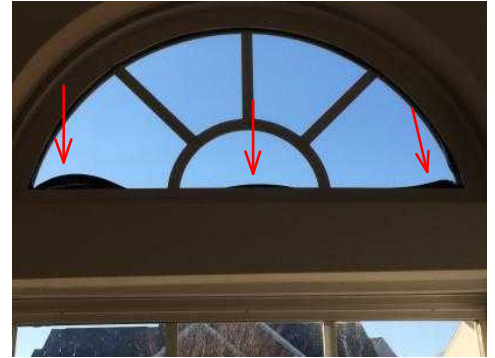
10. 1st Level Living Spaces Living Space Windows: Vinyl double hung, Non-opening Decorative windows in the front of the house have seals that are bringing to displace.

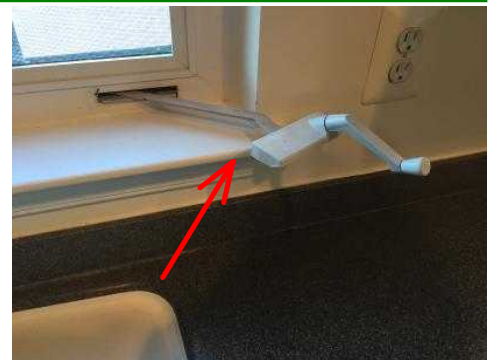
11. 1st Floor Kitchen Windows: Vinyl casement Defective hardware noted on kitchen window above the sink. Consider repair.

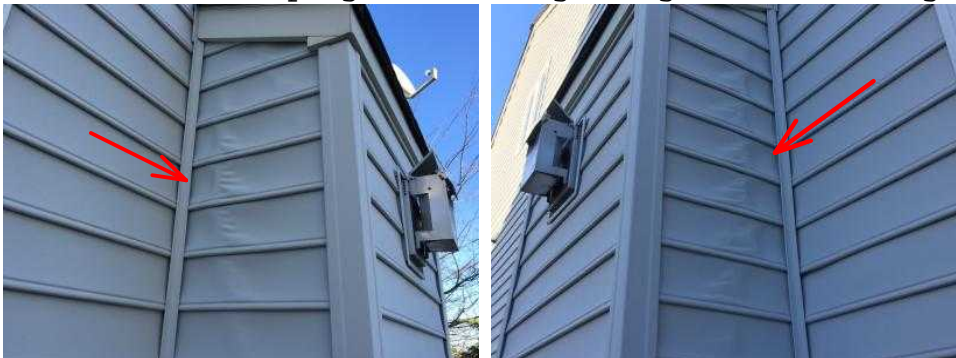
12. Family Room Fireplace Fireplace Construction: Prefab Melting noted on the exterior siding around the fireplace insert and venting system. Consider having a further evaluation done on the venting system to ensure it is correct. It is apparent that heat is escaping and causing damage to the siding.

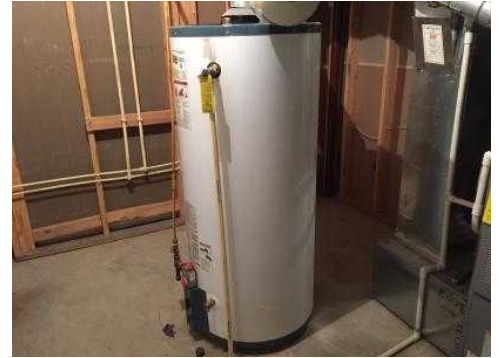
13. Basement Water Heater Water Heater Operation: Note: Gas was shut off to water heater at the time of this inspection. Could not verify if hot water is adequate however no signs of leakage or rusting is found.

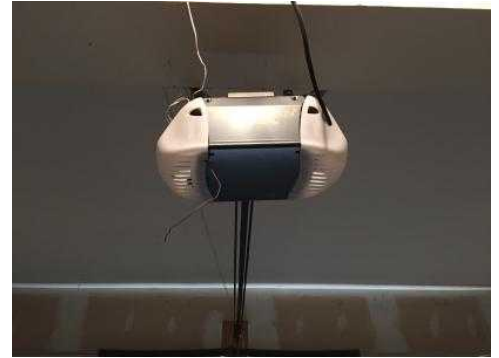
1. Attached Garage Door Operation: Mechanized Door opener does not work at this time. Consider repair.
